# UNDERWATER BRIDGE INSPECTION REPORT

STRUCTURE NO. 2519

CSAH NO. 22

RUM RIVER

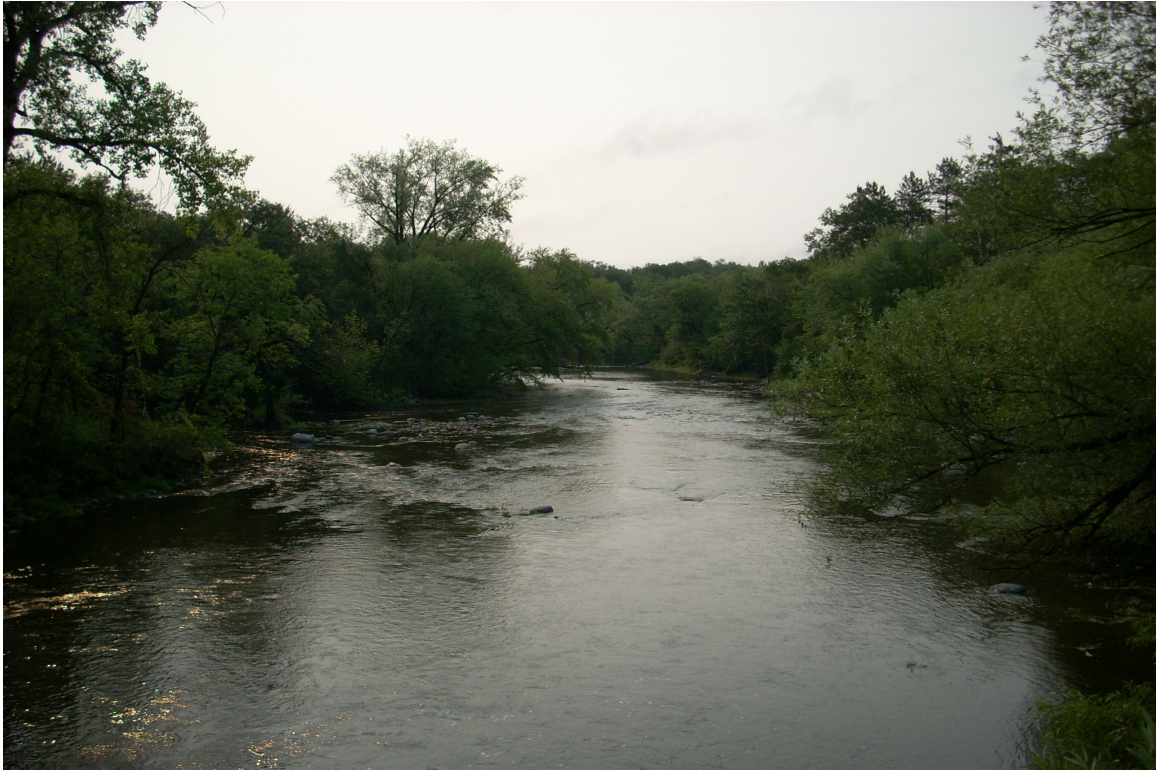
Photograph 1. View of Downstream Channel, Looking South.

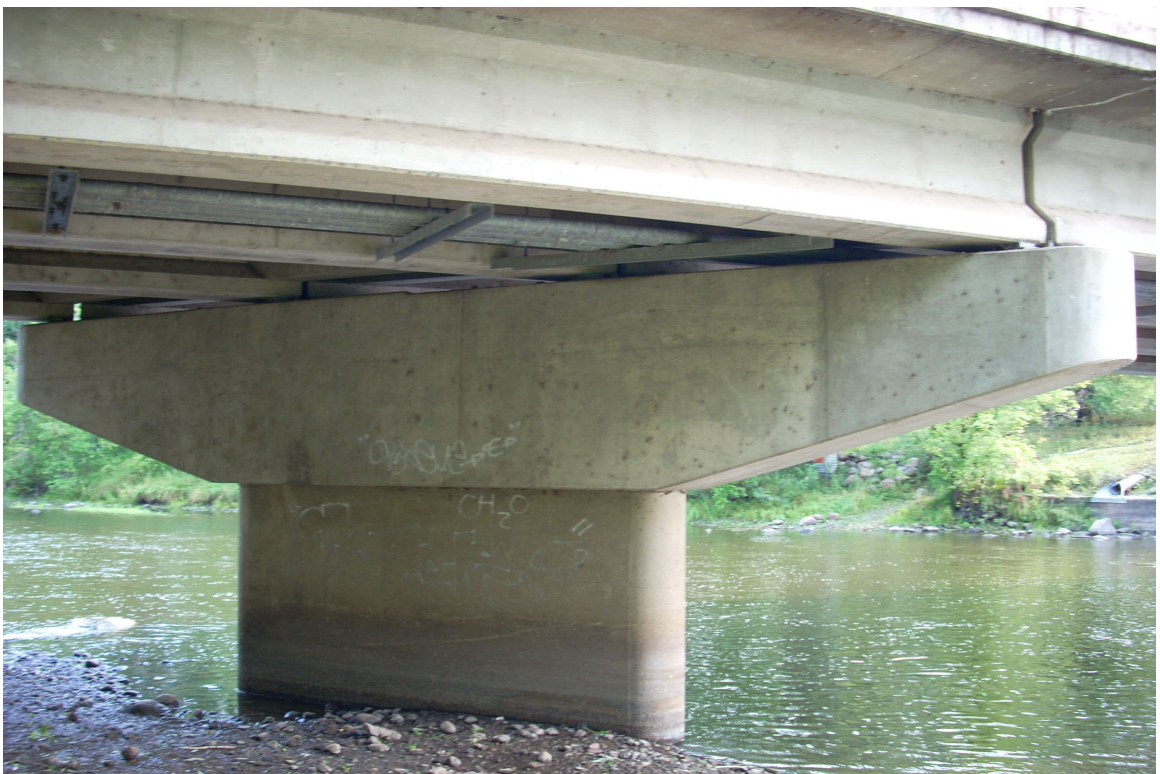
Photograph 2. View of Pier 1, Looking Northeast.

3. The top of the footing was exposed at 1.9 feet below the waterline along the east face of Pier 1 from upstream quarter point to downstream quarter point with no vertical exposure observed.

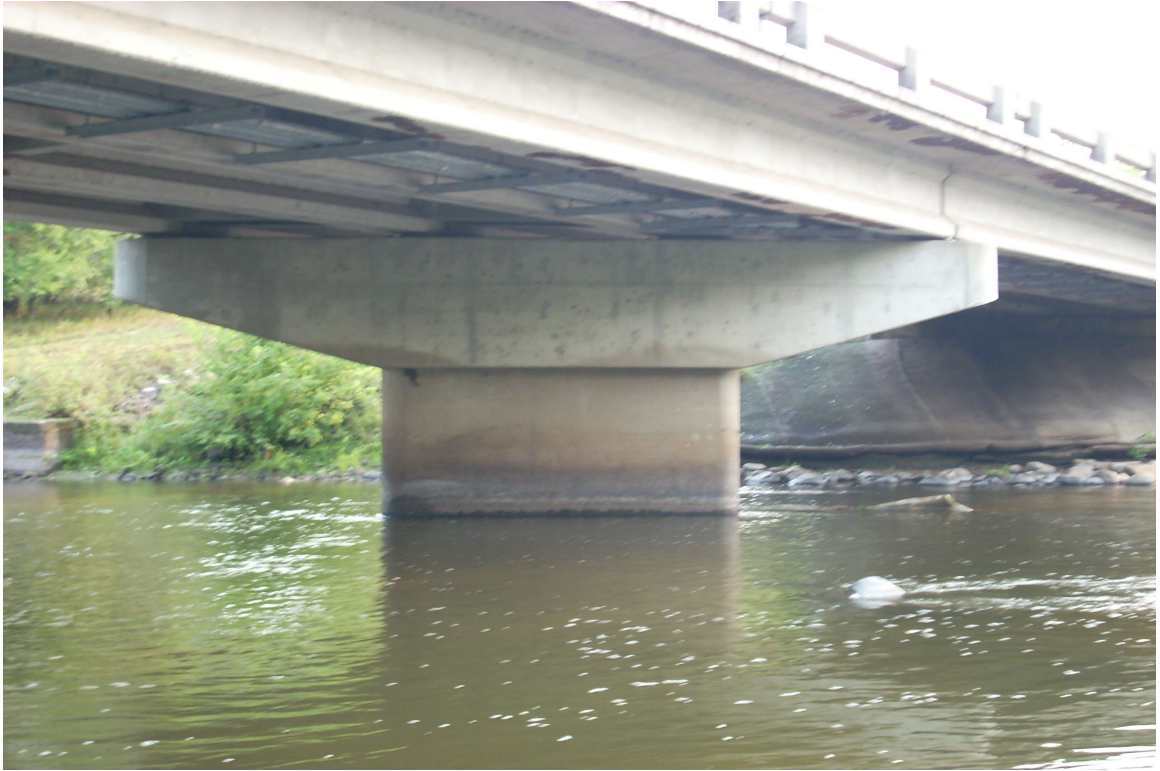
Photograph 3. View of Pier 2, Looking East.

4. The top of the footing was exposed at 4.2 feet below the waterline, around the upstream nose, and along the east and west faces from the upstream nose to the downstream quarter point, with no vertical exposure.

5. A moderate accumulation of timber debris was observed at the upstream nose of Pier 2, consisting of 8 inch diameter and smaller branches extending from the channel bottom up 3 feet and 8 feet long (East-West) by 3 feet wide (North-South).

6. A 20-foot-long by 2-foot-diameter log was observed along the east face of Pier 2 on the channel bottom.

\* Consideration can be given to removal of the timber debris accumulated around Pier 2 during normal maintenance operations, especially if it is found to be increasing in the future.

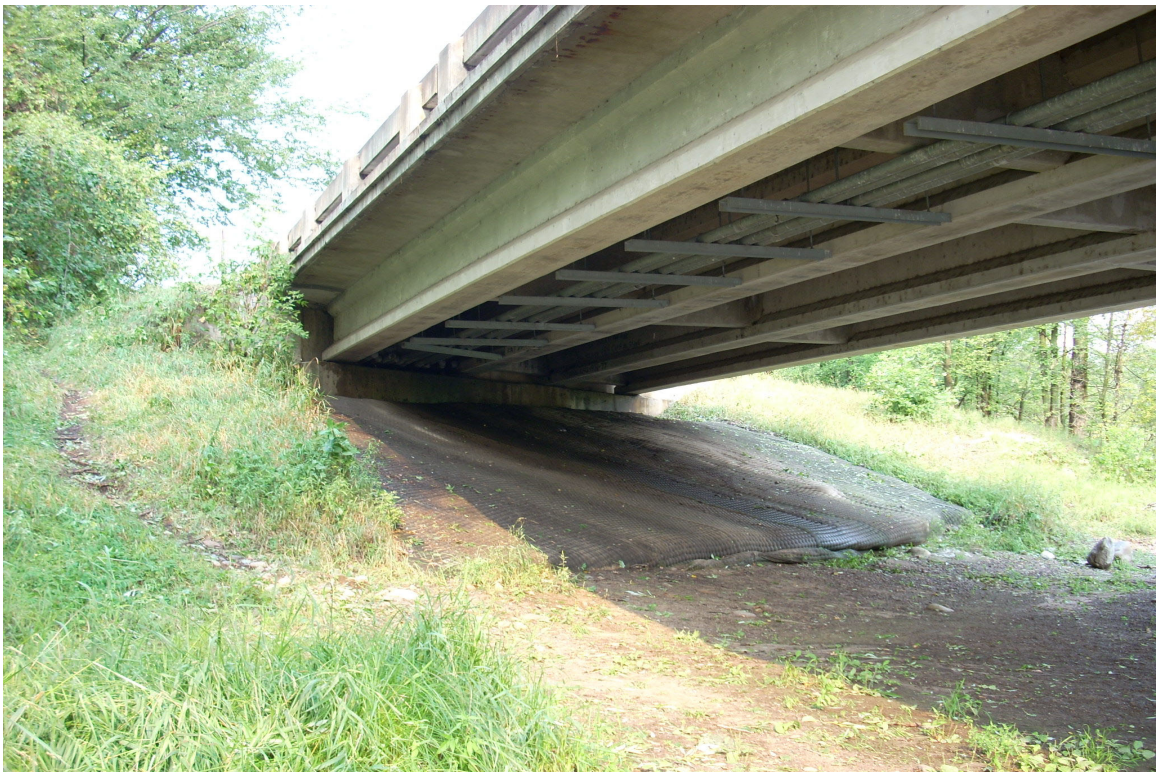
Photograph 4. View of West Abutment, Looking Southwest.

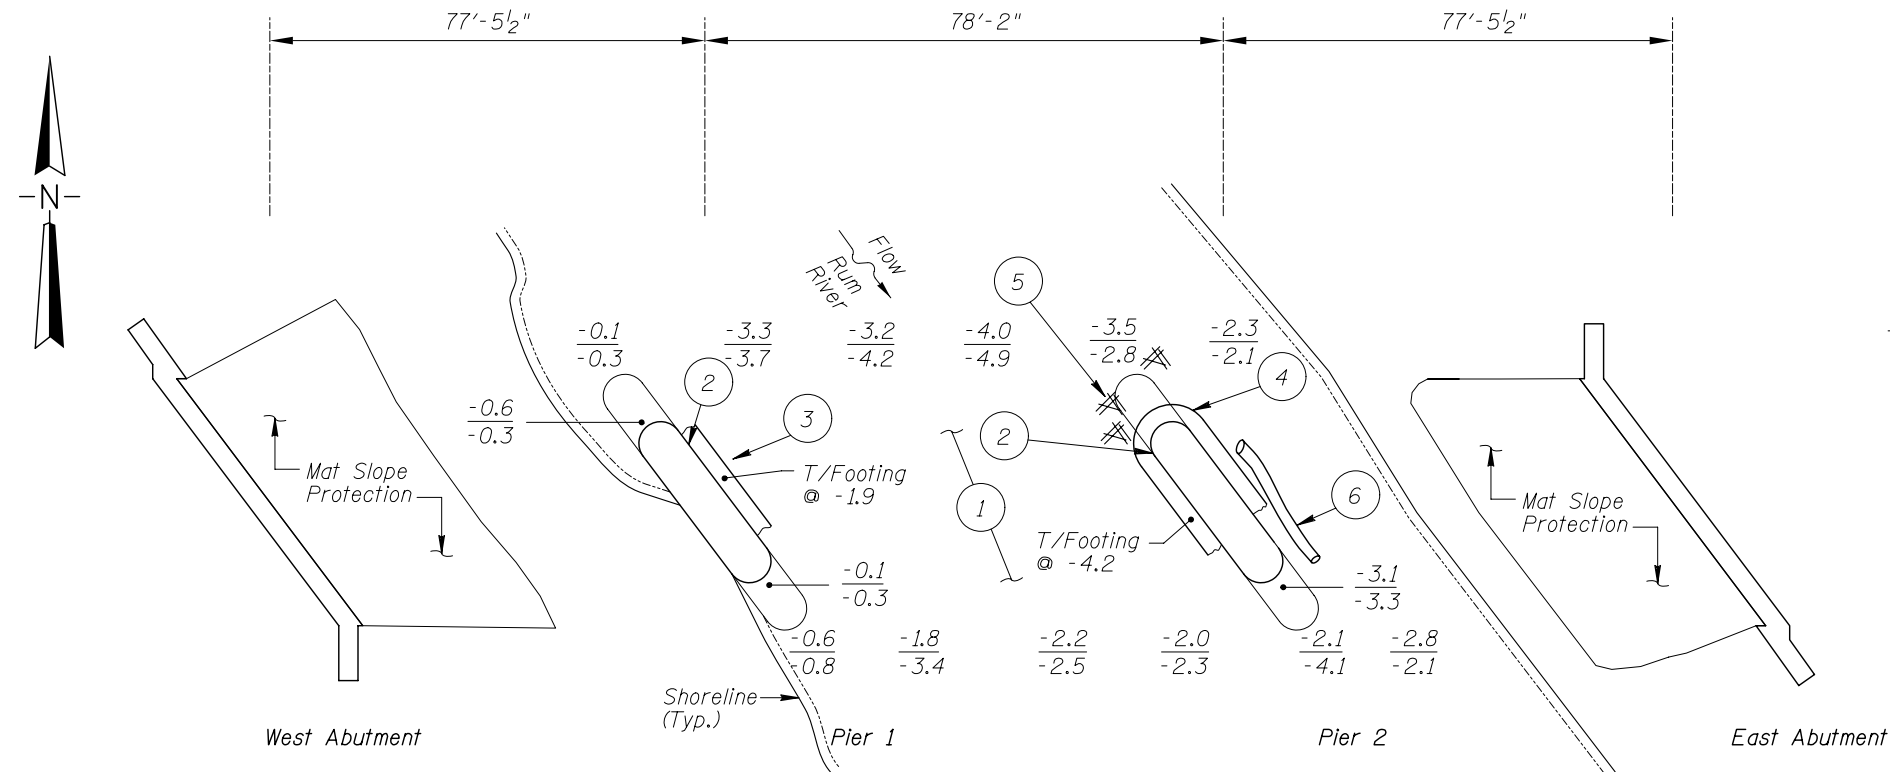
**INSPECTION AND SOUNDING PLAN**

1. The channel bottom material consisted of sand with scattered 2 to 12 inch cobbles.
2. A band of light scaling was observed from 1 foot above to 6 inches below the waterline around both piers with typical penetrations of 1/16 inch and maximum penetrations of 1/8 inch. Above and below the band of scaling the concrete was smooth and sound.
